**NASA CONTRACTOR REPORT 166522**

**Fused Silica Mirror Development for SIRTf**

William P. Barnes, Jr.  
Itek Optical Systems Division  
Litton Industries  
Lexington, Massachusetts

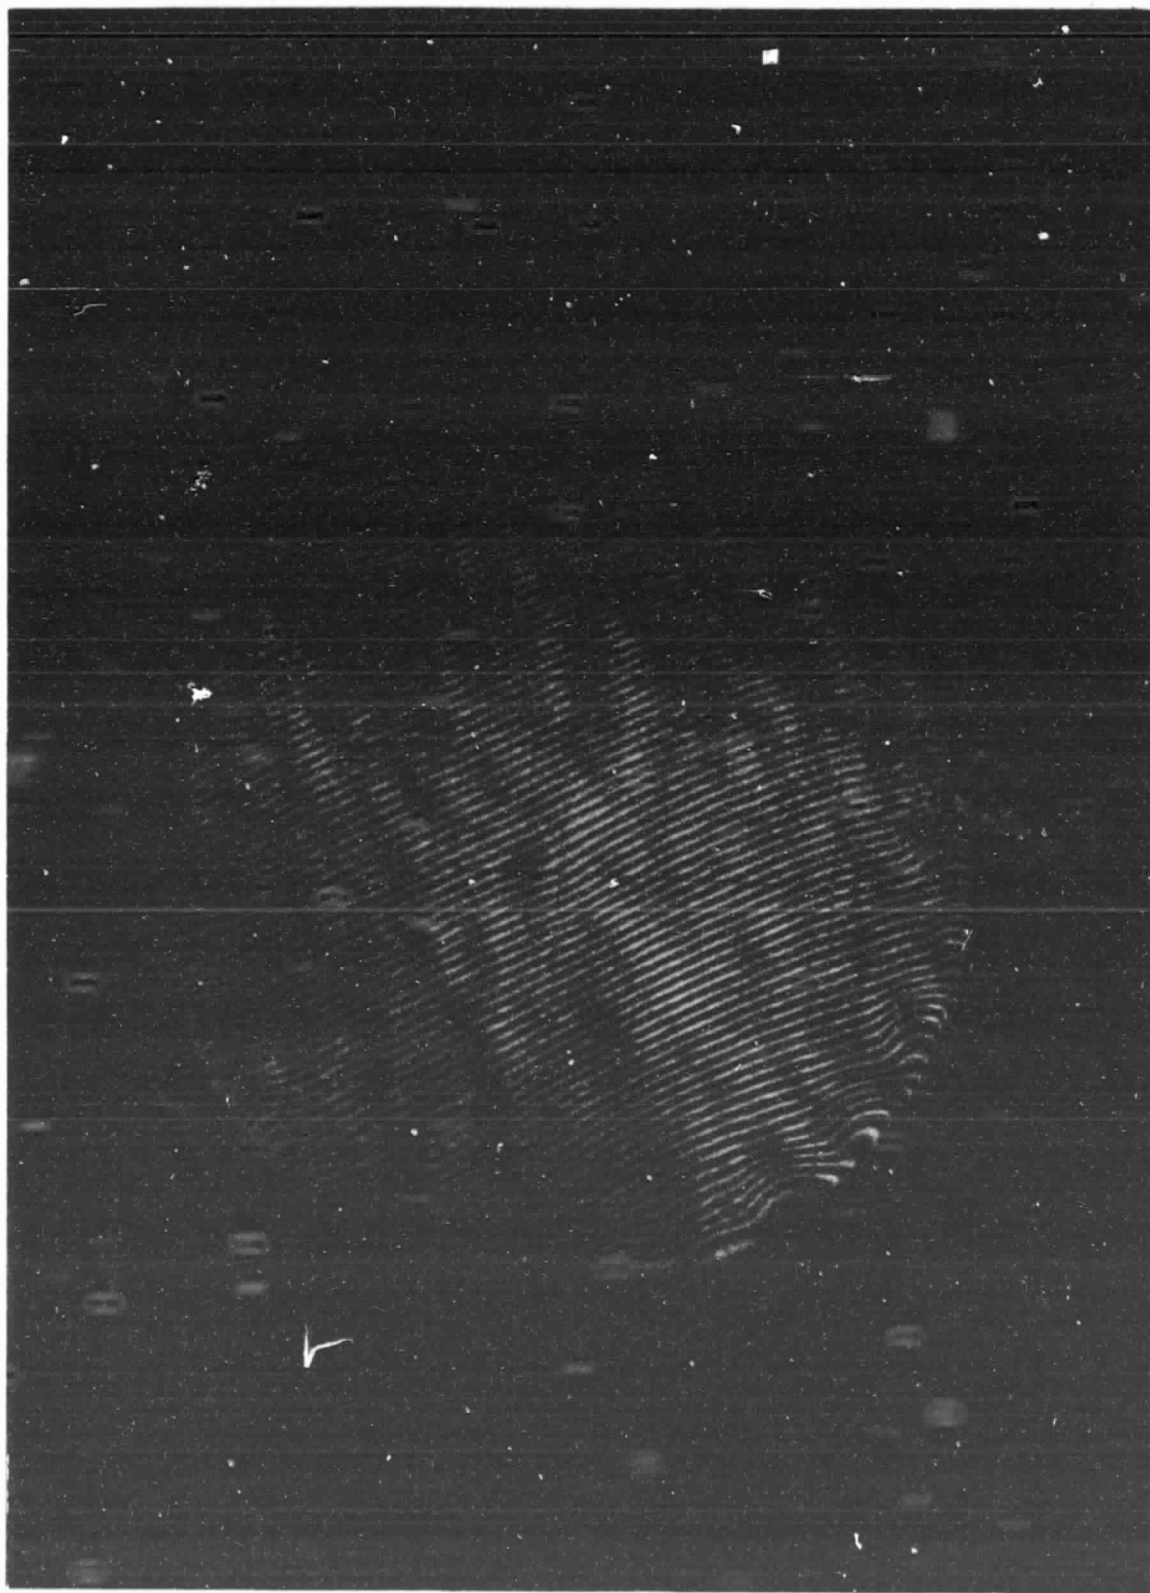
SIRTF MIRROR AND WINDOW INTERFEROGRAM  
AT LOW TEMPERATURE  
5-1c

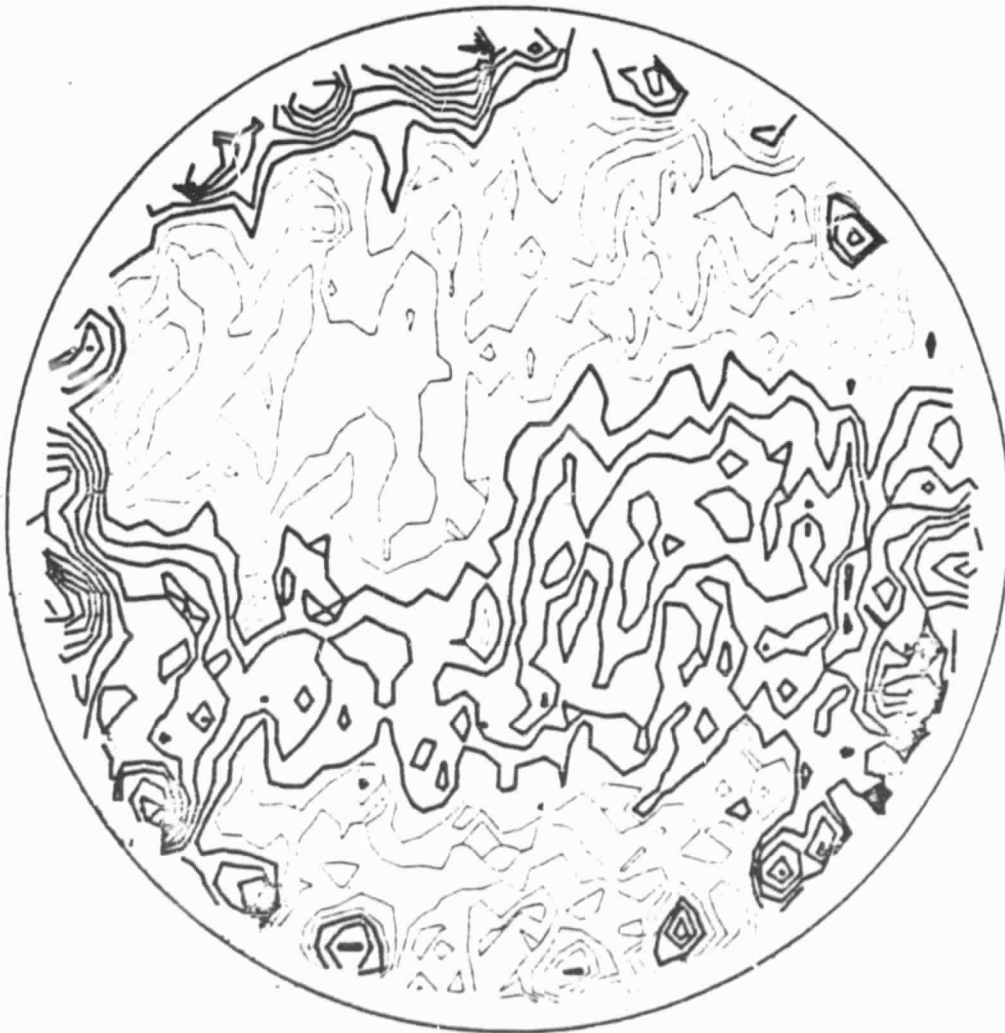
Figure 5-3

The most striking feature of these interferometric data, visible in Figure 5-1c and shown in more detail by the contour plots generated by digital data reduction, is the localized irregularity evident all around the outer area of the mirror. Figure 5-3, a surface contour map with 0.1 wave (633nm) contour intervals (heavy lines representing hills) illustrates these features. The hills correlate precisely with the hexagonal-celled structure of the mirror core. Further details of the reduced data are presented in Appendix D.

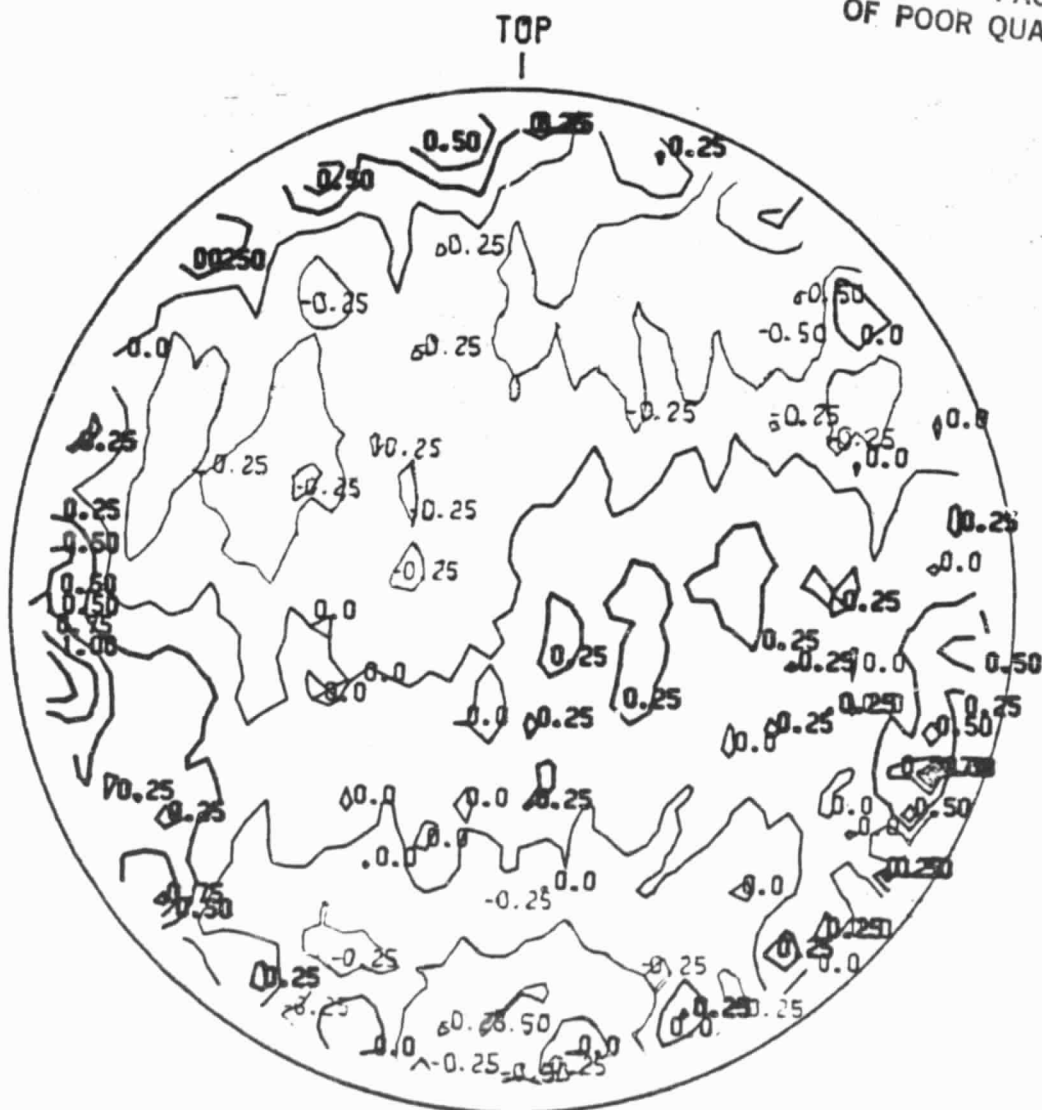
Figure D-3. Point-By-Point Subtraction

Figure D-2 minus Figure D-1
